## Loss Report

Date: January 4, 2005

RE: The Winn Apartment  
817 Fifth Avenue, NY, NY - 7<sup>th</sup> Floor  
Damage Sustained Due to Pipe Break

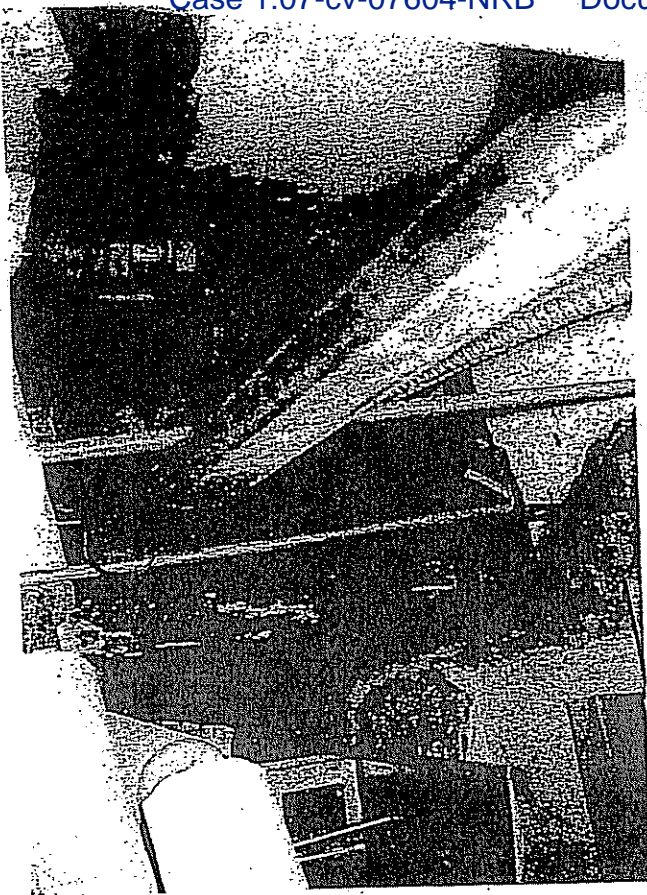
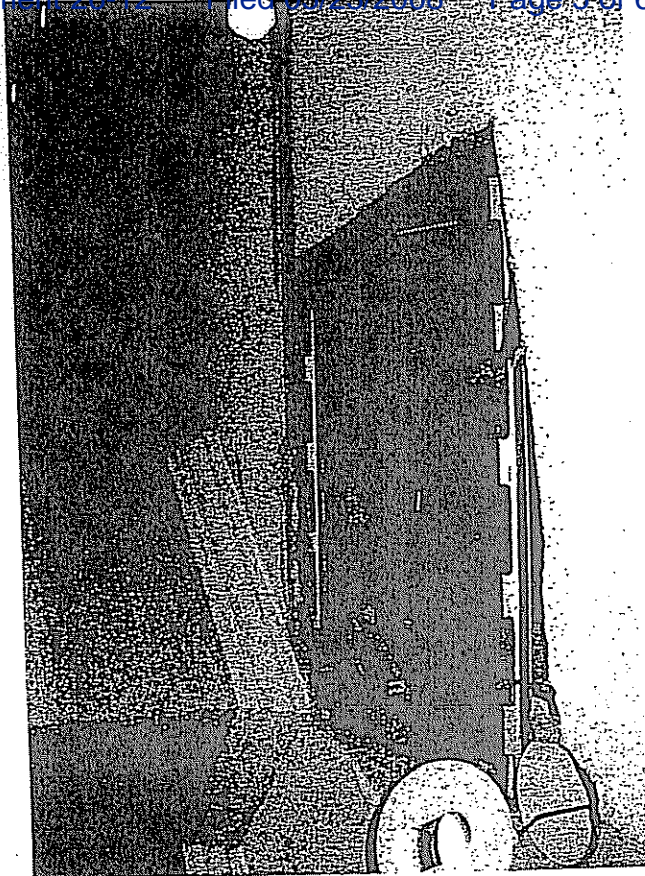
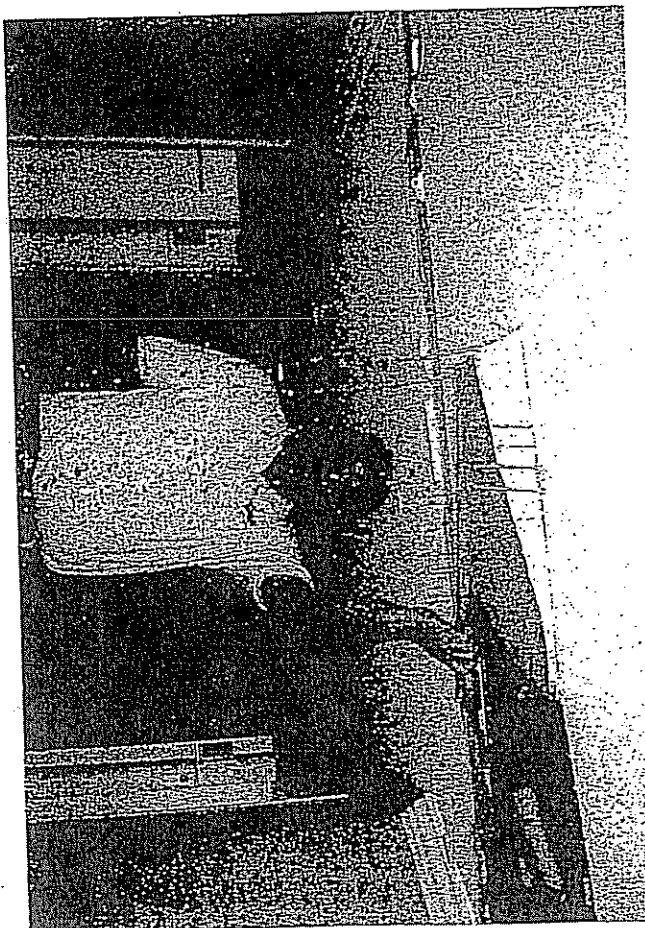
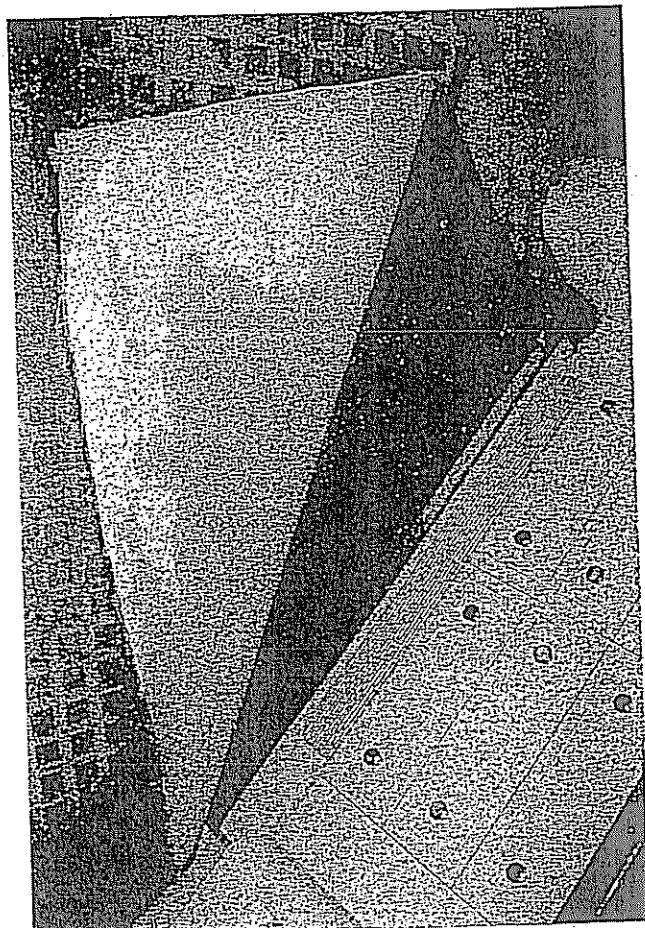
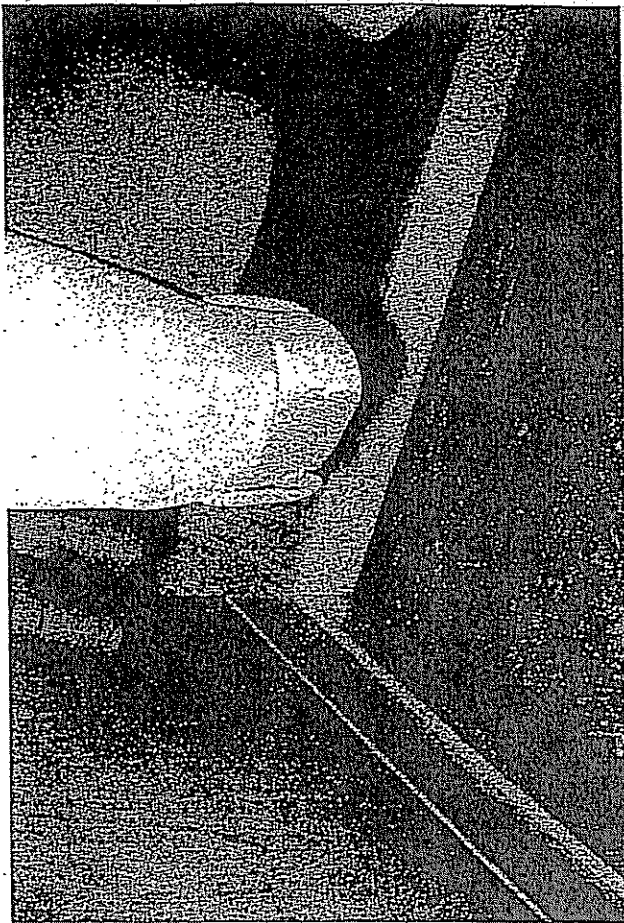
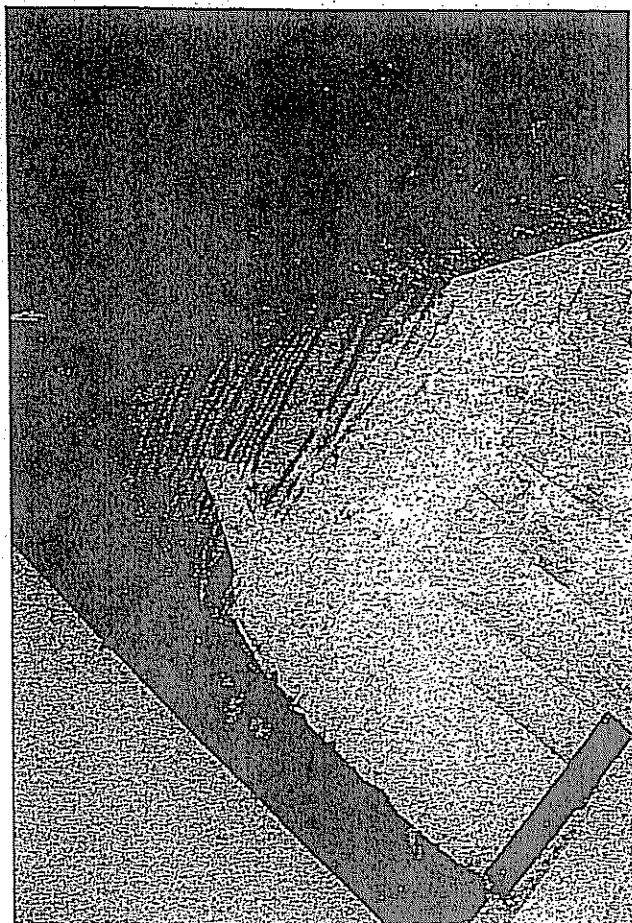
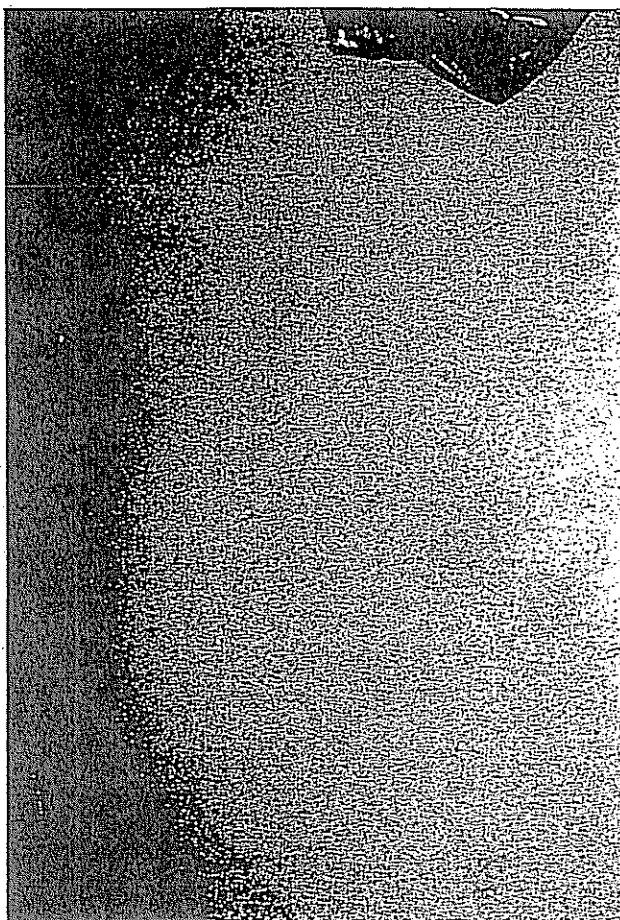
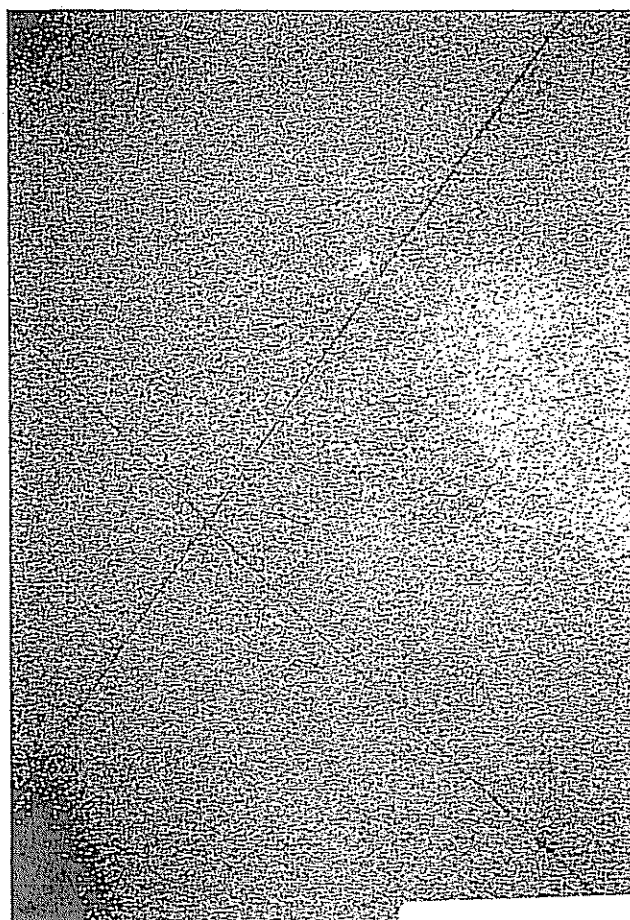
2. Hallway ceiling was badly damaged and dripping water from taped seams. Much of it had to be removed to keep the leak from spreading throughout the apartment. When the ceiling was opened, water cascaded down. Insulation in ceiling was completely wet, and was removed and disposed of.

4. Fabric panels along hallway were wet along tops. Approximately 6 linear feet from living room into hallway, panels were wet from top down (see attached pictures).

9. Carpet leading to ~~near~~ bedroom fully saturated until a few feet past linen closet.
10. All millwork trim along hallway is wet. Near powder room and master bath already showing warping.

12. Artwork along hallway was taken down by Maria and placed in living room. Some pieces are quite wet with very visible damage to flower painting. Paper on back very wet, and picture showing water damage. Metal medallion framed artwork is wet, with framing and back paper wet.

- When the ceiling was taken down next to the master bath, the drywall between the hallway and master bath, above the ceiling showed obvious water damage.

- Millwork trim is beginning to crack and spread apart at the seams. Base moldings are showing obvious warping.
- Stone flooring grouting along walls beginning to crack.
